# Lessons Learned from MARVEL Initial Fabrication and Testing

INL/RPT-25-84647

Department of Energy—  
Microreactor Program

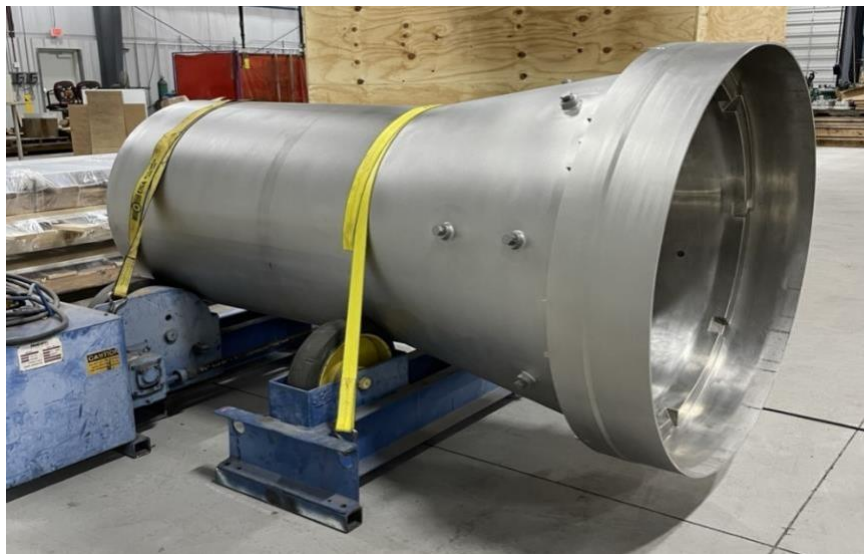
Figure 2. Completed MARVEL guard vessel (picture taken 01/2025).

This fabrication started in late January 2024 and was completed in late August 2024. Final testing (pneumatic pressure and helium leak tests) was completed in October 2024. A picture of the finished product is shown in Figure 2. Throughout guard vessel fabrication, INL assigned a resident quality engineer at the supplier's facility to witness all key fabrication, inspection, and test activities.

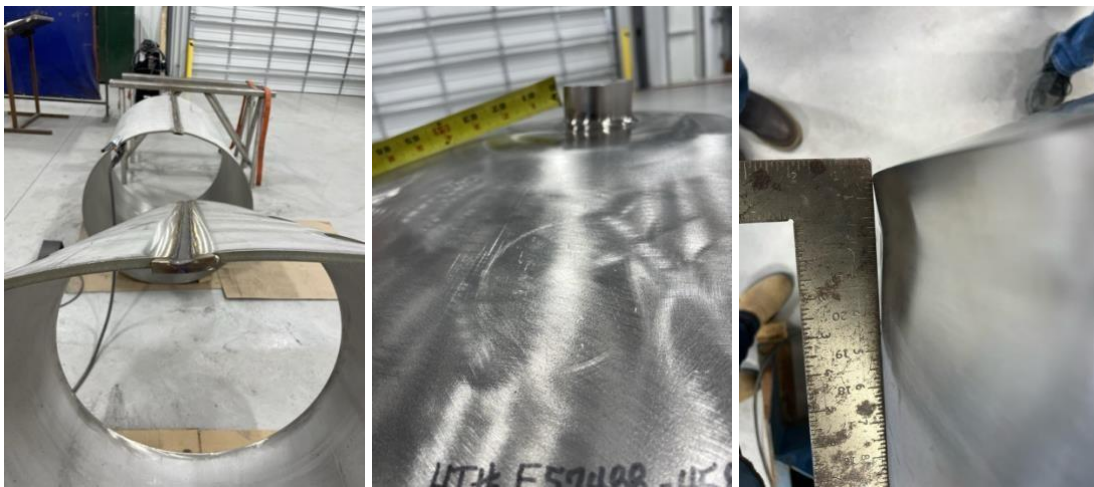
Figure 4. (Left) First occasion of weld distortion on the upper conical section of the guard vessel, where temporary attachments would have retained “roundness” and mitigated distortion (January 2024). (Center) Second occasion of weld distortion after welding the sump to the bottom cone, where the sump “sank” into the mating cone, which should have been restrained (April 2024). (Right) Third occasion of weld distortion following the welding of the lower transition ring on the bottom of the guard vessel (May 2024).

These particularities highlighted the need for specifications to include stringent requirements for weld distortion mitigation plans, encouraging suppliers to adopt proven fabrication techniques to control distortion. In defense of the fabricator, 316H-grade stainless steel has a propensity to distort more during welding—more than traditional 304/304L and 316/316L grades. The resulting distortions are shown in Figure 4.

After three instances of excessive, and preventable weld distortion, the MARVEL project mandated that a weld distortion mitigation plan must be in effect for all future welding on the vessel. This plan required the use of strongbacks and chill blocks to dissipate heat from the weld seam. The fabricator was receptive to developing a weld plan, and subsequent welding was successful. A cohesive and a well developed weld plan proved crucial in constructing a design-compliant guard vessel and minimizing rework.

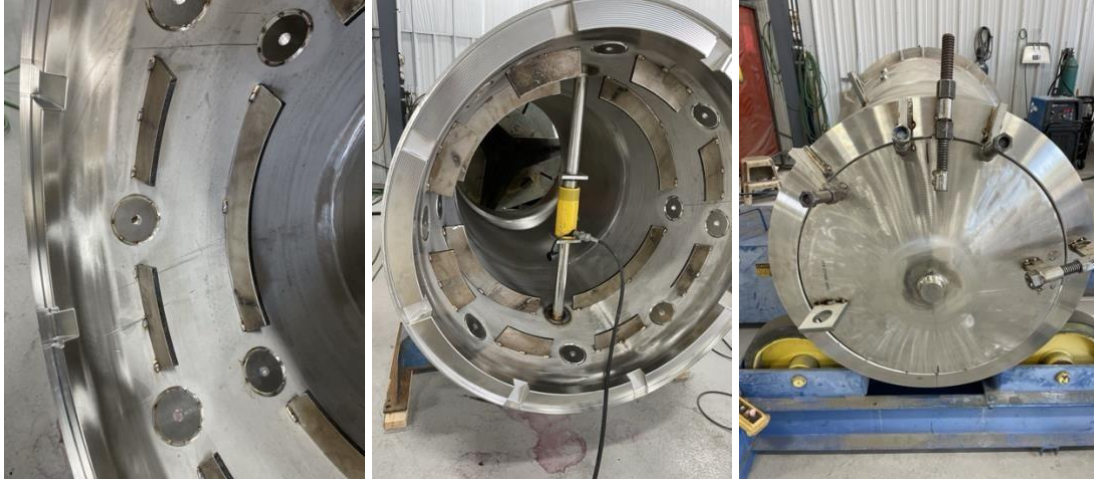
Figure 5. (Left) Strongbacks inside the guard vessel prior to welding the flanged couplings (April 2024). (Center) **A hydraulic jack used in concert with strongbacks to maintain pressure on the flanged couplings during weld out**, which prevented the “sinking” that had been evidenced on the sump plug to the lower cone weld (April 2024). (Right) Strongbacks and stiffeners prior to welding of the bottom cone of the guard vessel (August 2024).

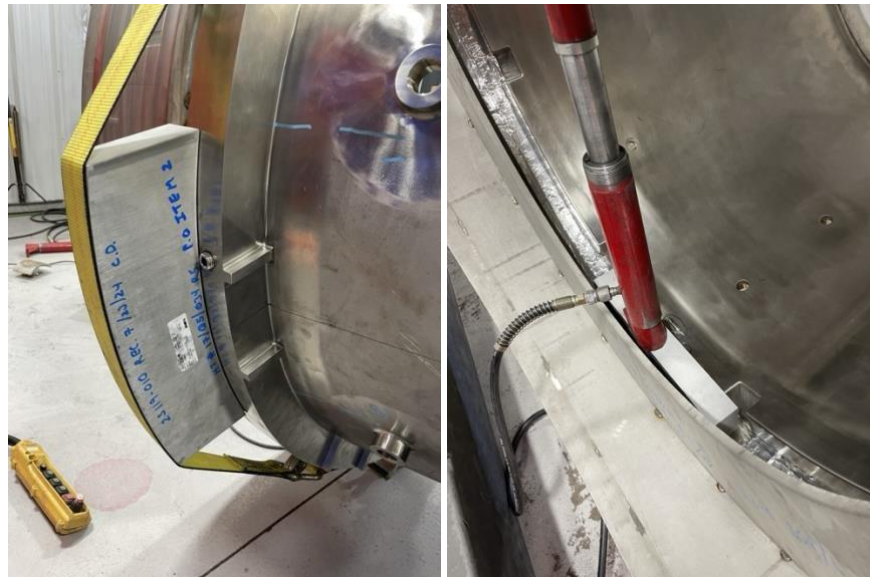
Figure 6. The top ring of the guard vessel necessitated finite tolerancing as this component served as the primary interface with the mating primary coolant system. Minimizing weld distortion in this zone was critical for functionality of the system. Note that the supplier used chill blocks on the inside (left image) and outside (right image) of the weld seam.

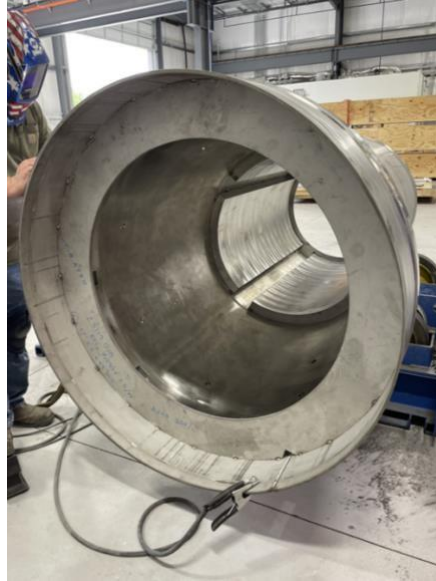
Figure 7. Fit-up of the internal shield plates to the vessel shell. Note that the supplier tack welded a temporary stiffener ring.

In addition to an INL request for the supplier to implement temporary fixturing and chill blocks, the fabricator was also proactive in suggesting additional solutions. The original drawings specified a single vee weld joint design for all weld seams on the guard vessel. A single-vee design provides a full penetration weld joint with all welding from one side; however, the ASME/BPVC Section III code also allows for a double-vee joint (i.e., welding from both sides). This approach equalizes the heat input to the joint, thus providing a more even distribution of heat. **To this end, the MARVEL engineering team reevaluated all remaining weld joints on the vessel and issued a drawing change specifying a double vee joint versus single-vee joint where appropriate.** This was a positive lesson learned, contributed to a compliant guard vessel, and further assisted in minimizing weld distortion.

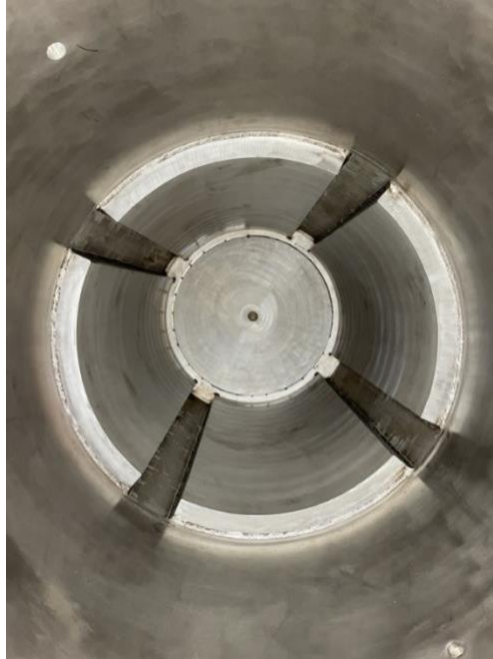
Figure 10. Completed fillet welds on the internal shield plates.

An advantage of the spray transfer mode is that it provides good fusion at the toes of the weld, whereas the short circuit mode deposits the filler metal at a colder setting. Thus, upon final inspection of the fillet welds, and although they met the required inspection criteria, it was evident that an alternative transfer mode (such as spray transfer or pulse spray transfer) would have yielded a fillet weld with less weld spatter and a faster deposition rate. To this end, the supplier was strongly encouraged to develop and qualify a procedure using these alternate transfer modes. Nonetheless (regardless of transfer mode), using the GMAW process did minimize heat shrinkage of the vessel wall.

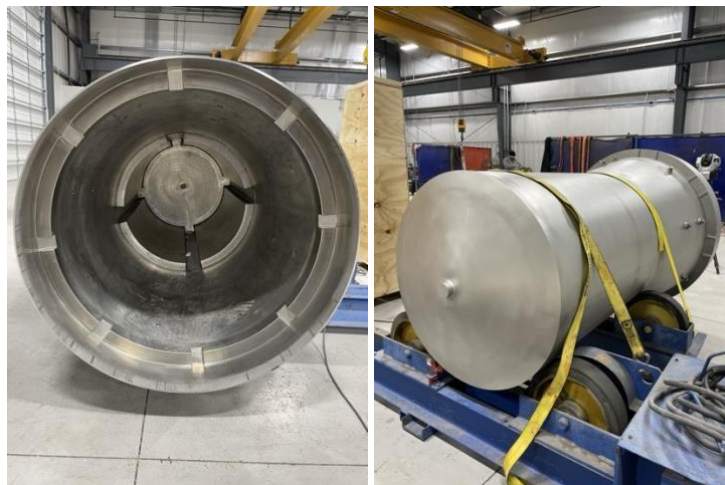
Figure 11. MARVEL guard vessel prior to inspection.

A positive outcome from the fabrication is that the vendor gained valuable experience on how to mitigate weld distortion throughout the fabrication. This learning experience is a fundamental benefit that aligns with the goals of the MARVEL and microreactor programs, which aim to reinvigorate manufacturing practices. **The development and application of effective weld distortion mitigation strategies by the vendor represent a significant step forward in enhancing fabrication quality and reliability for future projects.**

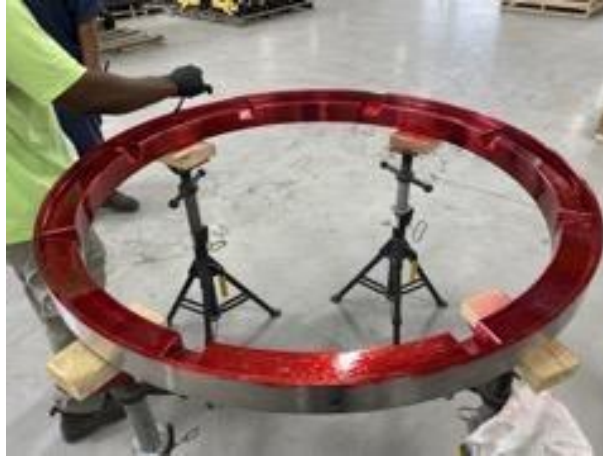
Figure 12. The plenum support ring was machined from billet 316H forging material (ASME SA182), requiring 100% liquid penetrant examination per Section III.

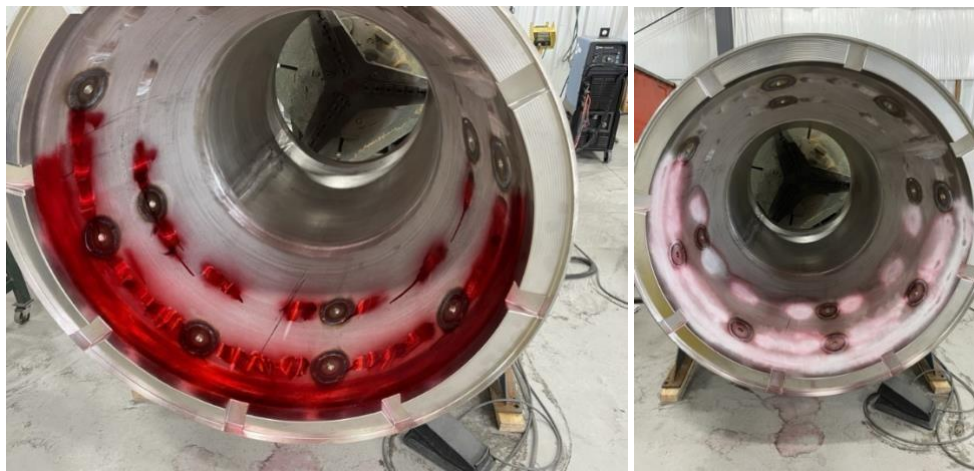
Figure 13. Dye penetrant inspection following the removal of temporary attachments.

Another nuance in ASME Section III, was the requirement for liquid penetrant examination following the removal of temporary attachments. **While there are a few unique requirements that exist in ASME/BPVC Section VIII, Section III necessitates that liquid penetrant examination applies to the removal of *all* temporary attachments (reference ASME/BPVC Section III, Div. 1, Article NB4435). In addition, this requirement in Section III is more prescriptive than its Section VIII counterpart—where each location is required to be identified, marked, recorded and inspected.** Again, this should be a noteworthy consideration for other reactor developers.

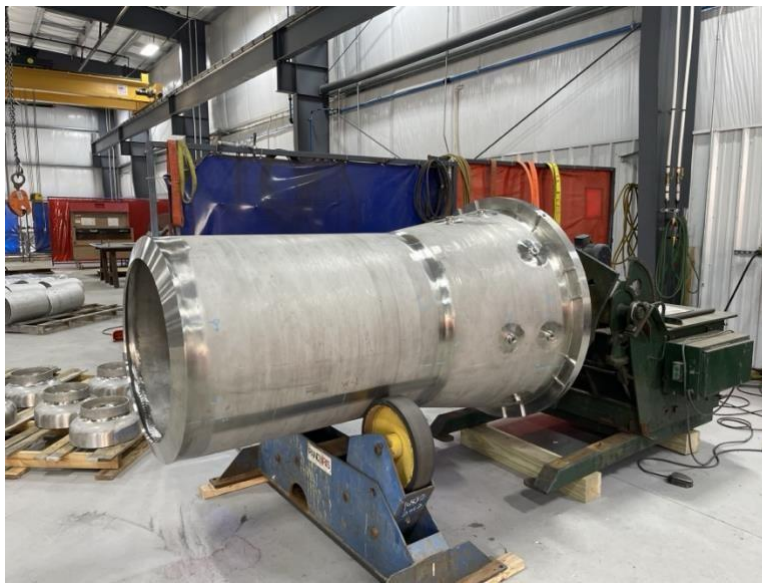
Figure 14. Completed MARVEL guard vessel.

Weaknesses were noted during the initial set up of the guard vessel where the fabricator did not implement traditional leveling and layout techniques. Not employing essential fabrication methodology, such as establishing quadrant lines on the vessel and leveling the rolls, hindered the fabricator throughout fabrication. The absence of datum lines on the vessel compounded the challenges with fit-up of the internal shield plates. These components had to be oriented to a specific datum to accommodate the downcomer piping of the primary coolant system. Additionally, the fabricator did not utilize advanced measuring tools (such as a coordinate measuring machine [CMM] or romer arm) during in-process fabrication and fit-up activities. **Had the fabricator employed all the tools at their disposal and adopted traditional vessel layout techniques, the supplier would have reached conclusive dimensional acceptance results. The absence of these layout lines hindered the quality control dimensional inspector in achieving consistent measurements during the final dimensional inspection, thus the project experienced a delay in furnishing “as-built” dimensional inspection reports.**

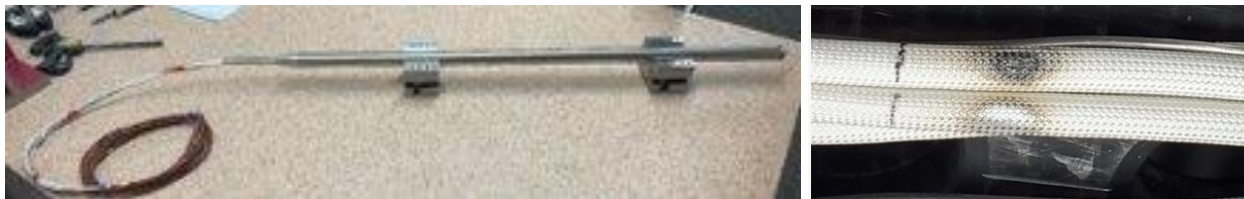
Figure 16. (Left) PCAT heater tube and cartridge heater pigtail and (right) heater insulation damage due to end cap welding.

During final inspection, it was discovered that the heat generated from welding the end caps damaged the heater assemblies, which proved to be more significant than the insulation damage. This was more significant because later bowing and twisting during heat up of PCAT could lead to heater failure if the heaters made contact. Further, the uncertain dimensions of the coolant channels between the heaters could introduce unquantified errors into the RELAP5-3D (Reactor Excursion and Leak Analysis Program) model validation that is dependent on MARVEL data. Examples of bowing are shown for one heater in Figure 17.

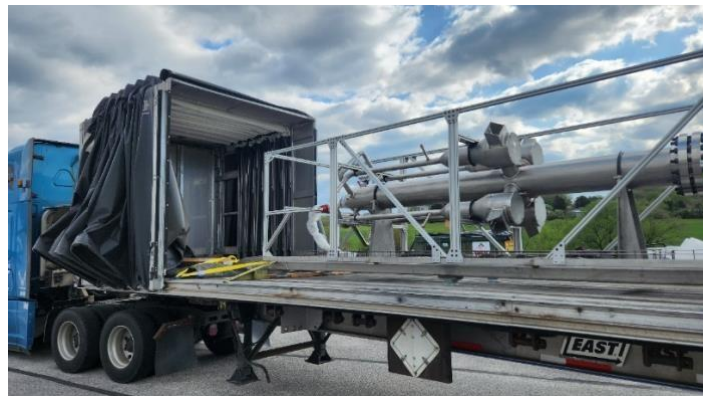
Figure 18. PCAT loaded on transport truck.

PCAT was shipped to the testing vendor in April of 2023 (see Figure 18). Upon arrival at the testing vendor, several challenges were encountered. The cables that were installed at INL to connect the heaters to the control cabinet were intentionally left long due to the unknown nature of the final installation.

**This additional length caused an increased transmission of noise to the controllers.** As a result, the wires were trimmed and re-terminated. Due to engineering requirements and the modification of INL-provided equipment, this was required to be performed by INL personnel specifically, as opposed to the designated testing contractor. These and other issues, such as **calibration questions (typical of a large experiment start-up), delayed completion of PCAT setup until July 2023, at which time the setup and assembly were completed.**

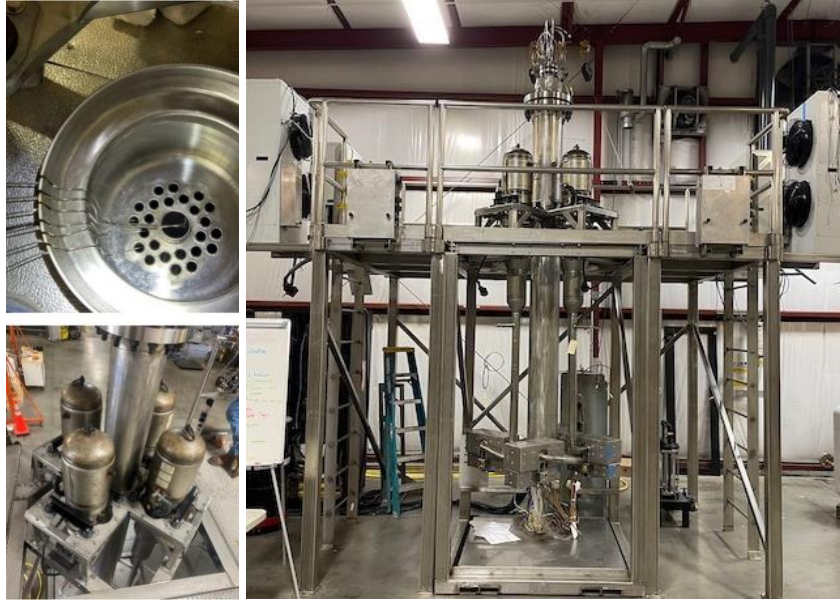
Key parts of the PCAT setup are shown in Figure 19. Thermocouple (TC) wires are shown routed to the intermediate heat exchanger, which would subsequently be filled with LBE. The entire assembled PCAT is shown, without insulation. Blowers on either side of the platform remove heat from the Stirling engines. In September 2023, the PCAT system and associated instrumentation were deemed ready for testing.

Figure 19. MARVEL assembly and setup at Creative Engineers Incorporated (CEI), including (top left) TC wires inside heat exchanger, (bottom left) Stirling engines installed, and (right) PCAT assembled and setup at CEI (without insulation).

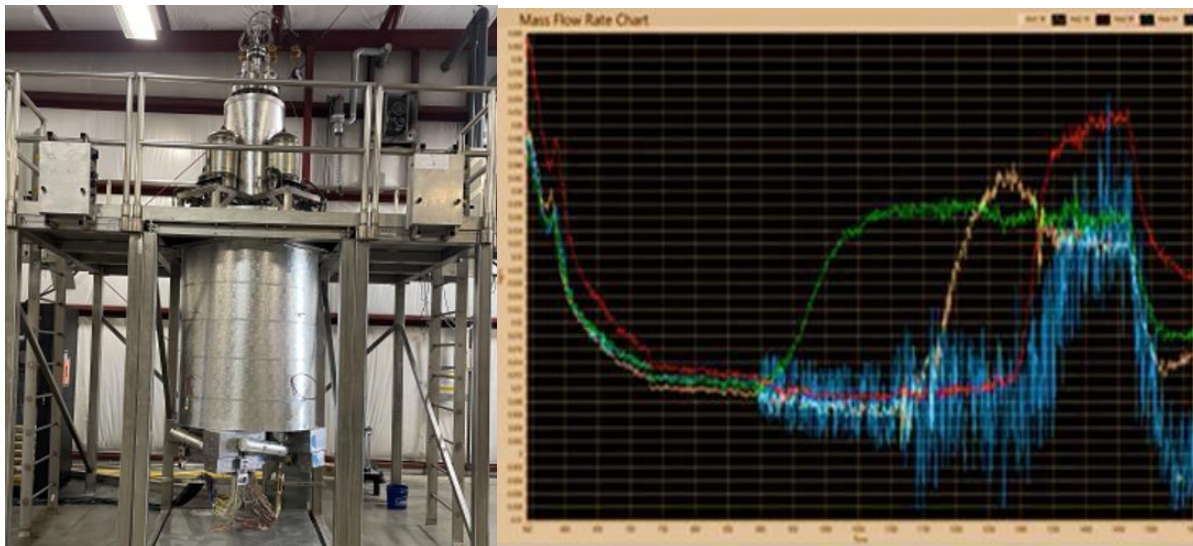
Initial testing of PCAT was performed on September 19, 2023. During this testing, natural circulation of the primary coolant was detected from heat-up. As the four Stirling engines were started sequentially, coolant flow increased in commensurate fashion. Power output was measurable from all four engines. Final assembly of PCAT and the mass flow rate for all four Stirling engines during initial testing is shown in Figure 20.

Figure 20. (Left) PCAT assembled and setup at CEI (with insulation), and (right) Stirling engine mass flow rate chart indicating natural circulation in each engine during initial start-up.

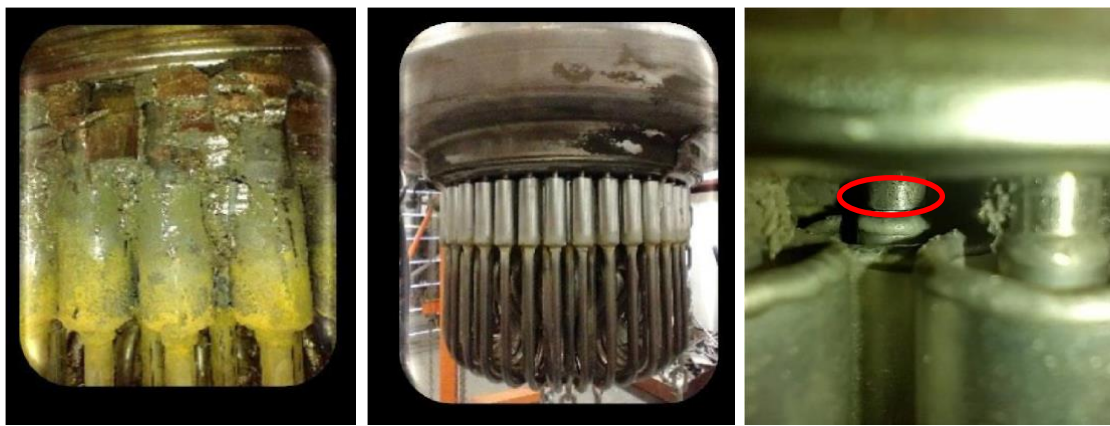
In preparation for qualification testing at full power, a series of low-power ramp tests were performed in March 2024. During these tests, two engines failed. Later, all of the engines were removed for inspection. There was substantial oxide build-up on the Stirling engine heat exchanger (HX) tubes and a common-mode of tube failure, as shown in Figure 21.

Figure 21. Images showing (left) oxide build-up on Stirling engine HX tubes, (center) Stirling engine HX tubes after cleaning, and (right) Stirling engine HX tube failure.

**Based on the investigation team's engineering judgement, the tube failure was caused by the freezing of the LBE.** This freezing, and subsequent expansion, caused the support of the Stirling engine to transfer from the engine structure to the HX tubes and subsequently the tube welds. The commercially available Stirling engines procured for PCAT do not account for mechanical load on the tubes and are only tested for leak tightness not structural strength. **This is a result of using commercial items in conditions substantially different from their design conditions.**

- A light argon purge was placed on the molten LBE pool to reduce the oxygen around the pool and prevent oxide formation. This required the design of a standalone argon system and a modest equipment purchase.
- Prior to installation, the engines were visually inspected and photographed for existing wear. During installation and prior to operation, the inspection verified that the engines sat freely and that there was no initial system contact with the tubes.

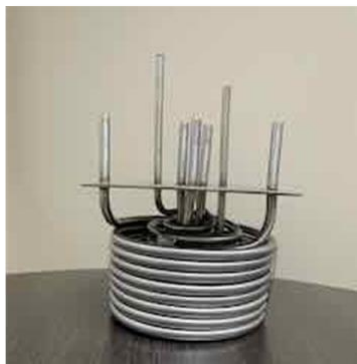
Alternative heat extraction method were evaluated. The goal was to select the least obtrusive option to meet the goals of operating PCAT. Ultimately, the team tested a coiled heat extraction loop shown in Figure 22. The alternative heat extraction loop was designed to fit in the location of the former Stirling engines with minimal reconfiguration and utilized the same propylene glycol and water mix and heat offtake as the Stirling engines.

Figure 22. Alternative heat extraction for PCAT.

This initial prototype showed promising results and allowed the team to extract approximately 30 kW of heat from PCAT. With the concurrence of the MARVEL design authority and program sponsor, the team proceeded with the fabrication and installation of the remaining three cooling loops. This work was
