# **Comprehensive Evaluation of the Advanced Moderator Module (AMM)**

*Microreactor Program M3 Report*

# Comprehensive Evaluation of the Advanced Moderator Module (AMM)

## *Microreactor Program M3 Report*

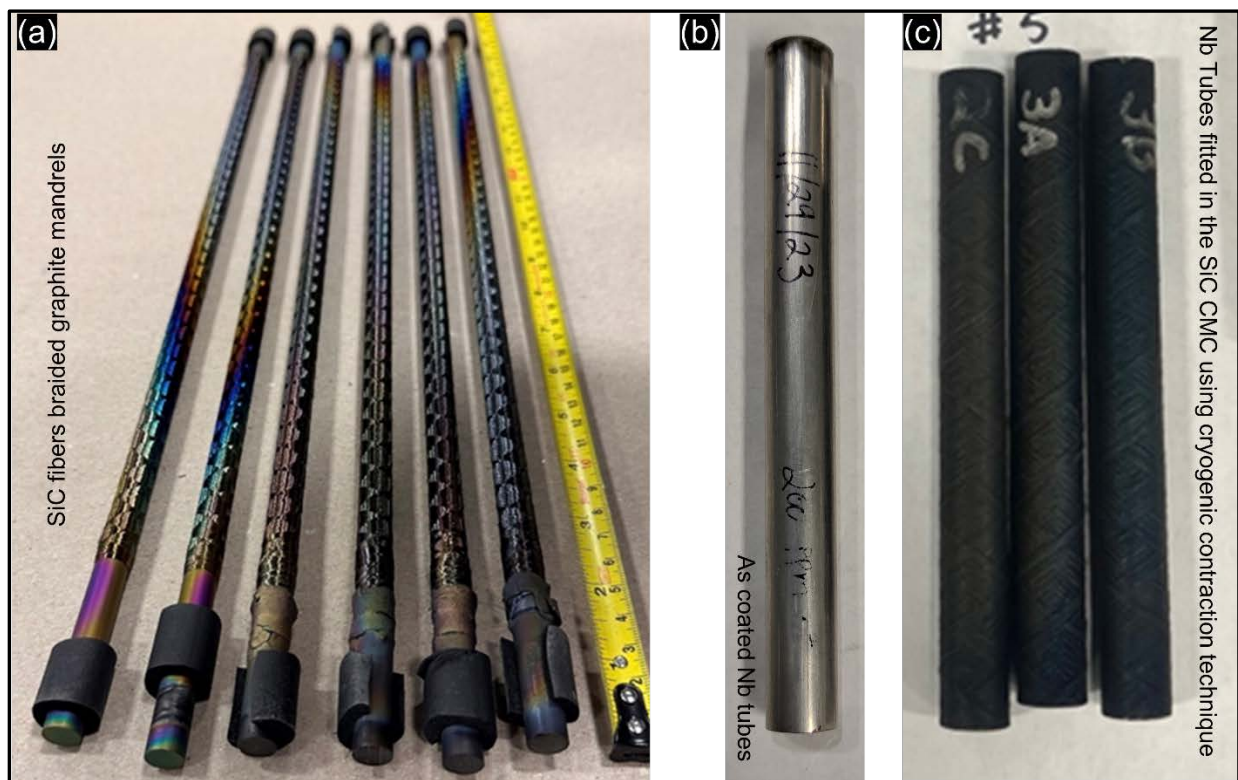
**Figure 4:** (a) SiC fibers braided graphite mandrels (~50 cm long) after going through the process pyrolytic carbon coating to generate a layer of carbon over the fibers for better bonding with PIP SiC matrix. Picture credit CTP LLC. (b) 10 cm long, as coated Nb tube sections shipped to CTP & (c) 10 cm long coated Nb tubes shrink fitted within SiC CMC shells.

multiple layers of SiC-based fabrics into the desired configuration. As depicted in Figure 4 (a), CTP has braided beta-phase SiC fibers over ~9.5 mm OD graphite mandrels to match the ID of the coated Nb liners, followed by the deposition of a layer of pyrolytic carbon over the braiding to enhance bonding with the PIP SiC matrix.

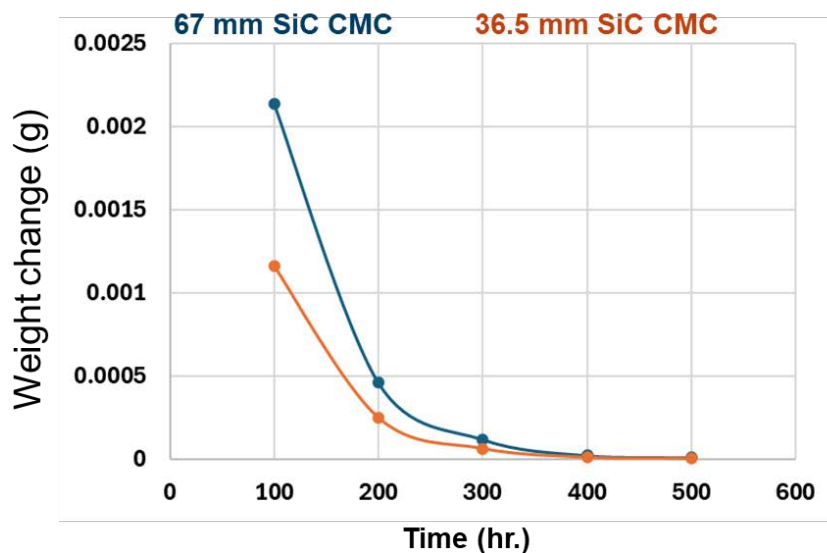
**SiC composite shell**

O.D. : 10.8 mm – 11.2 mm  
Wall thickness: 0.45 mm  
Length: 67.0 mm

To quantify this effect, dedicated thermal exposure experiments were conducted on SiC CMC shells of varying lengths. Figure 11 presents both a representative image of the SiC CMC shell (left) and the measured weight loss versus time for two different shell lengths: 67 mm and 36.5 mm. The weight-loss behavior follows an exponential decay trend, with the majority of mass loss occurring within the first 200 hours at  $750\ ^\circ\text{C}$ , after which the curves asymptotically approach a plateau. Importantly, longer SiC shells exhibit proportionally higher de-gassing contributions, consistent with greater exposed volume of composite material.

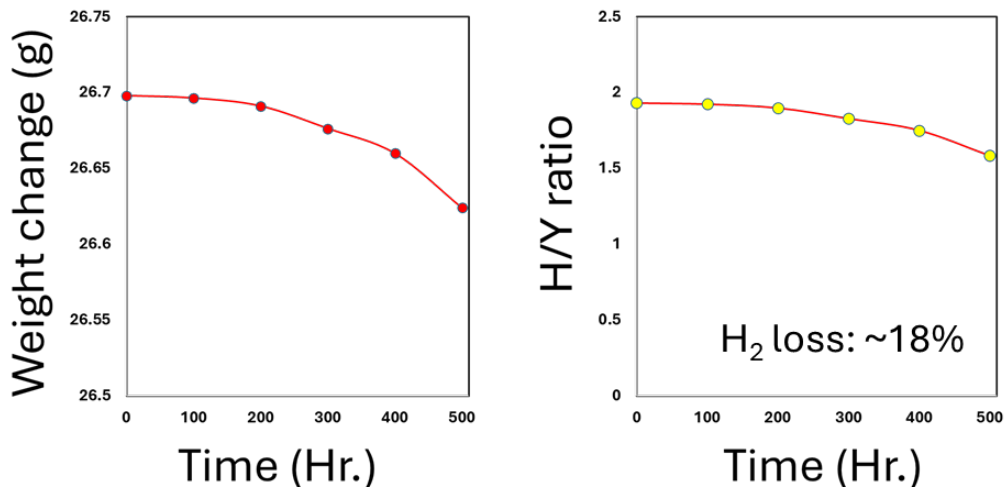
**Figure 14.** Measured H/Y ratio evolution for AMM modules with 500 nm  $\text{Al}_2\text{O}_3$ -coated Nb end caps tested at  $750^\circ\text{C}$ . (a) Argon (1 atm, 50 sccm flow) and (b) vacuum ( $\sim 5 \times 10^{-6}$  mbar). Both cases show substantial hydrogen loss, with ~21% loss in vacuum and ~18% loss in Argon, confirming that single-layer coatings are insufficient for  $\text{H}_2$  retention.

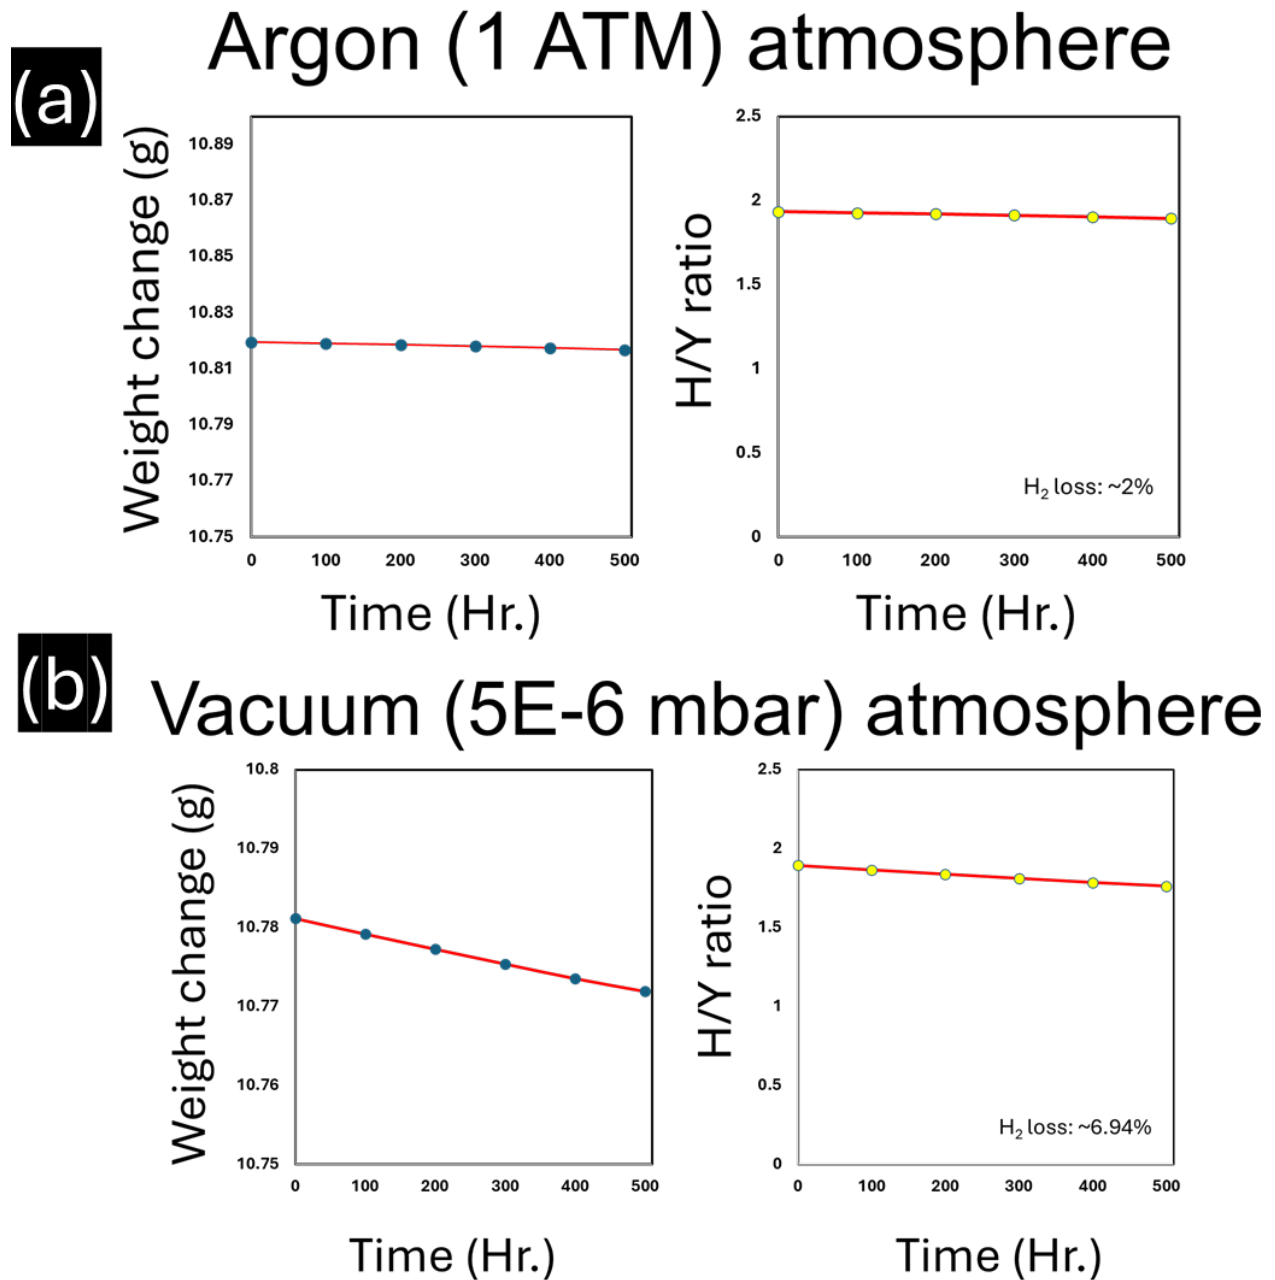
**Figure 18.** Hydrogen-loss trajectories for the same AMM module with the  $1.2\ \mu\text{m}$  multilayer on end caps, (a) Argon,  $750\ ^\circ\text{C}$ , 500 h at ANL: shallow, ~linear decline corresponding to  $\approx 2\%$  H loss. (b) High vacuum,  $800\ ^\circ\text{C}$ , 500 h at LANL: steeper decline corresponding to  $\approx 7\%$  H loss, attributed to tensile stress in vacuum plus Arrhenius increase in permeability and higher thermal-mismatch stresses at  $800\ ^\circ\text{C}$ .

behavior was significantly different, where a ~7% hydrogen loss was found, which is substantially greater than when it was tested in argon, see figure 18 (a, b).

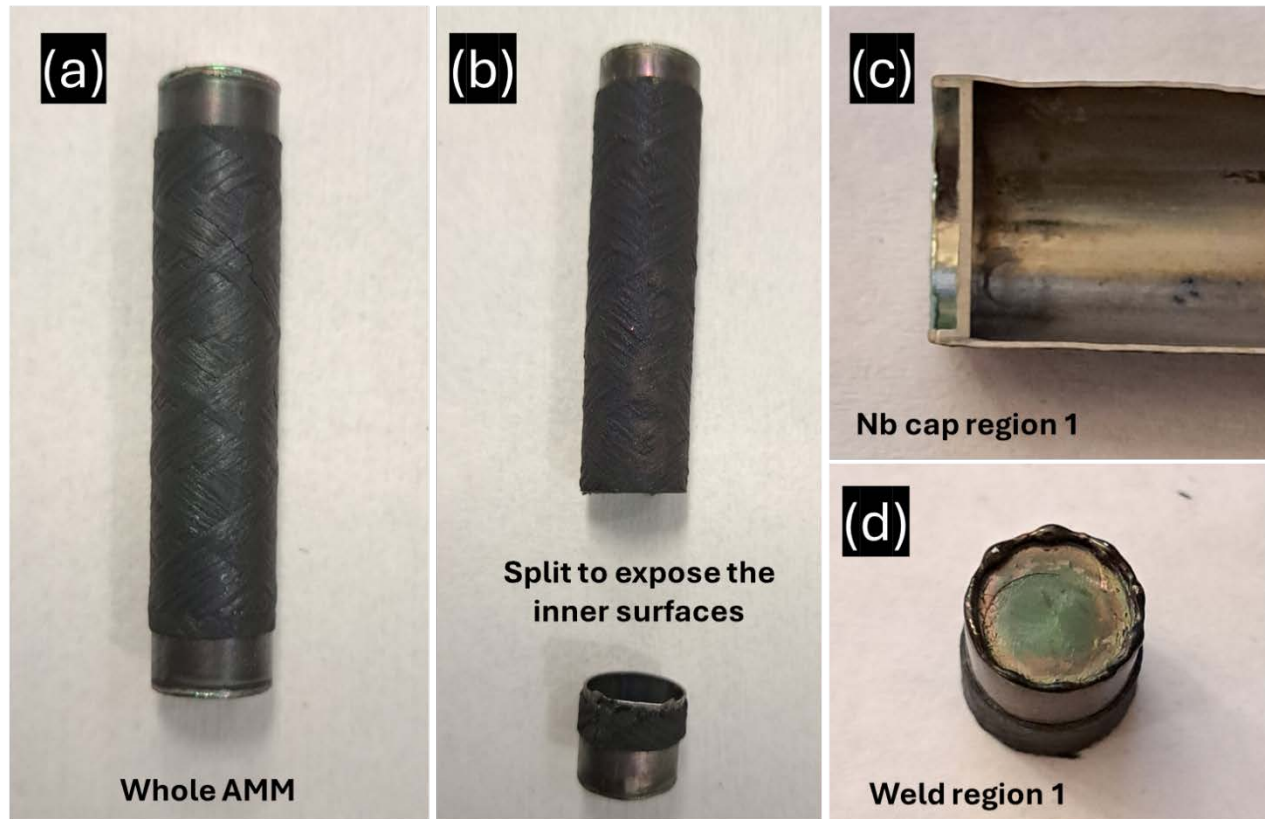
**Figure 22.** Optical images of the AMM module with multilayer-coated Nb cap region ( $2 \times 300$  nm Al<sub>2</sub>O<sub>3</sub> +  $2 \times 300$  nm Cr). (a) Whole AMM module following thermal testing, (b) split AMM exposing intact inner surfaces, (c) Nb cap region showing slight discoloration, and (d) weld region highlighting surface features following exposure.

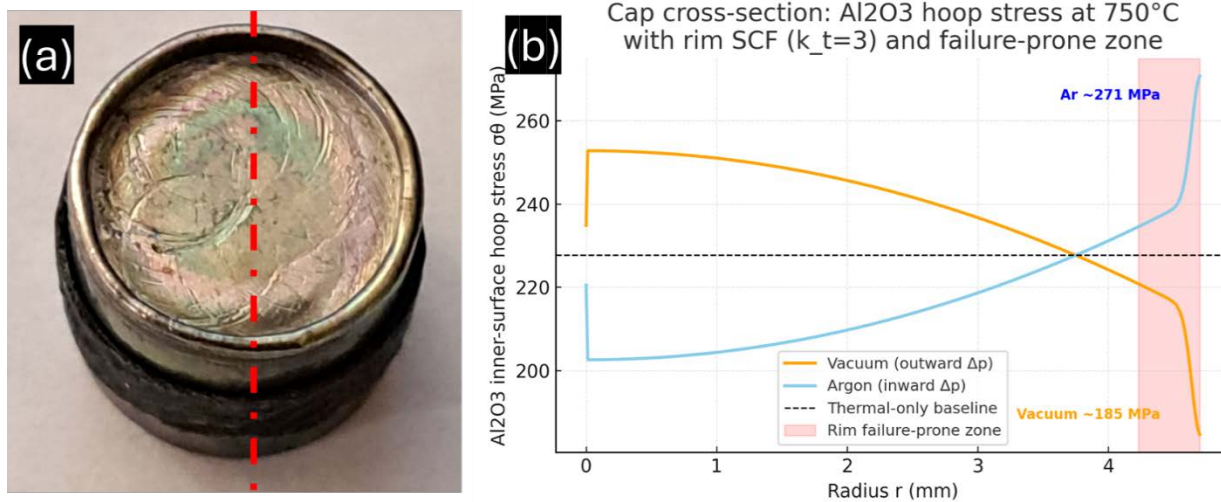
**Figure 26.** Hoop stress distribution in a 500 nm  $\text{Al}_2\text{O}_3$  single-layer coating at  $750^\circ\text{C}$  under vacuum and argon environments, showing rim stress concentrations driving fracture and coating failure.

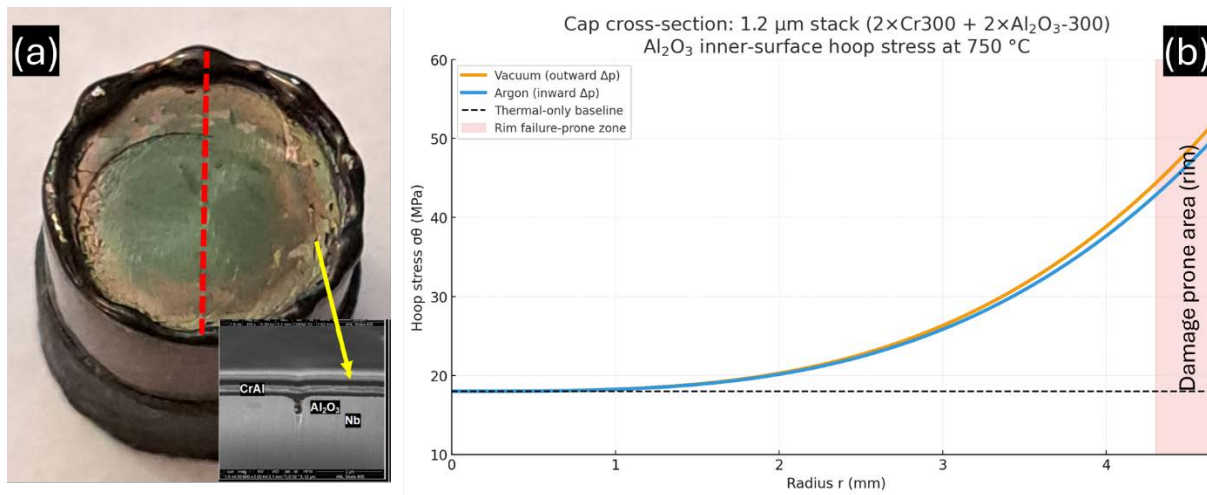
**Figure 27.** Hoop stress distribution in the Nb end-cap region coated with a  $1.2\ \mu\text{m}$  multilayer stack ( $2\times\text{Cr-300 nm} + 2\times\text{Al}_2\text{O}_3\text{-300 nm}$ ) tested at  $750\ ^\circ\text{C}$ , showing stress concentration at the rim and correlation with observed coating failure.

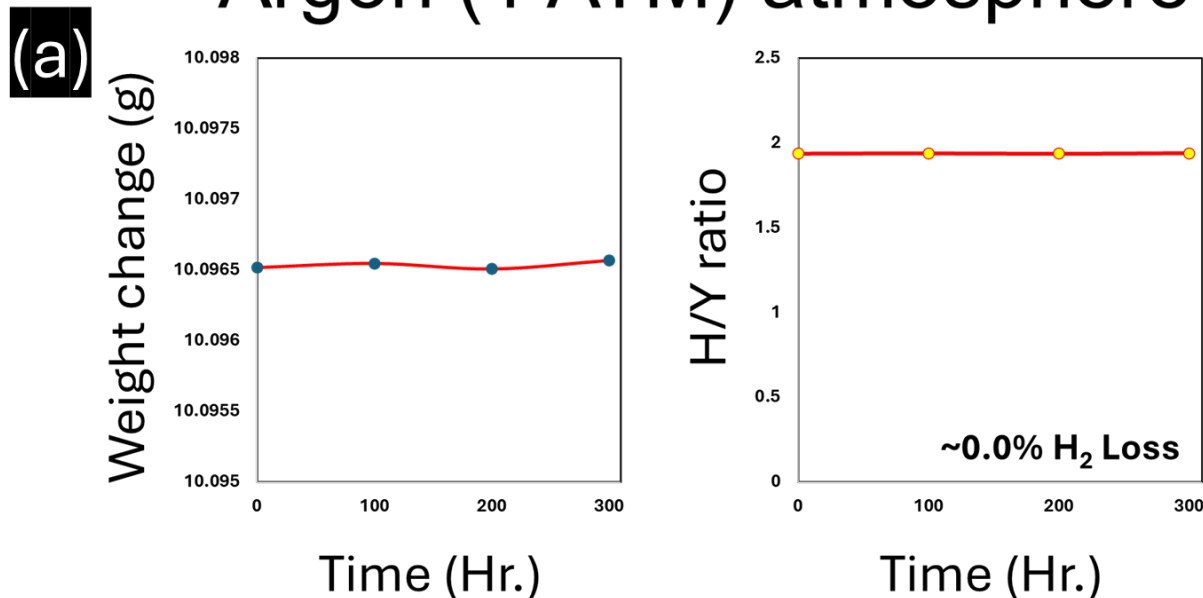
**Figure 29.** Measured hydrogen weight retention profiles for the 3.2  $\mu\text{m}$  multilayer-coated AMM modules tested at 750  $^{\circ}\text{C}$ : (a) under argon atmosphere for 300 hours, and (b) under vacuum for 300 hours. Both conditions show negligible hydrogen loss, indicating excellent hermetic performance of the multilayer stack at the Nb cap regions.
