# Chloride Salt Flow Loop and Corrosion Studies

Idaho National Laboratory

**MSR Review Campaign Meeting, Apr 21-24 2026**

# AMMT Molten Salt Corrosion: FY26 Tasks at INL

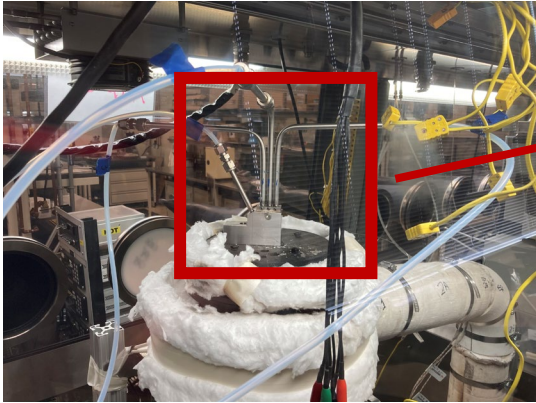
Modified triple bubbler installed in the molten salt flow loop

- Triple-bubbler sensor deployed for in situ density monitoring in molten LiCl-KCl
- Density inferred from differential gas pressure measurements
- **Negligible flow effect** observed under tested laminar-flow conditions
- Stable response with <1% density uncertainty under tested conditions
- Enables **real-time tracking of salt temperature changes** during loop operation.
